Attachment

The following pages show images that were obtained during recovery attempts of obliterated serial numbers on various firearms. The image quality presented here is limited by resolution of the printing equipment used to produce this hardcopy of the photos. In addition, the quality of the images was limited by the photographic skills used to capture the original pictures. The following presentations should be viewed, therefore, as somewhat inadequate visual aids meant to enhance and illustrate the observations made on the opening page of each firearm study.

Remington 12 gauge shotgun

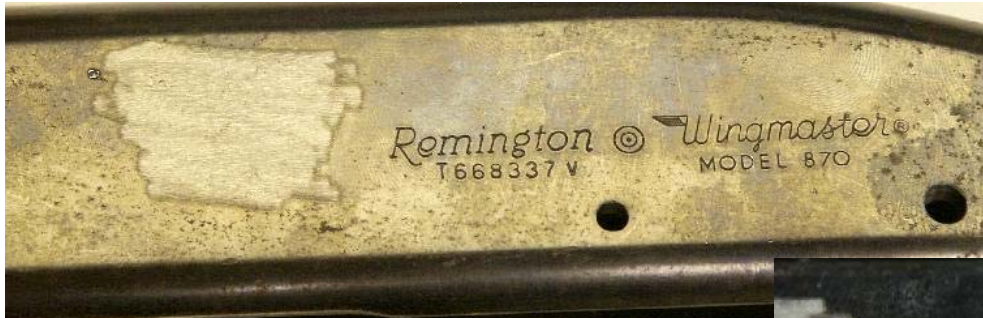
As received – Remington
shotgun #T668337V

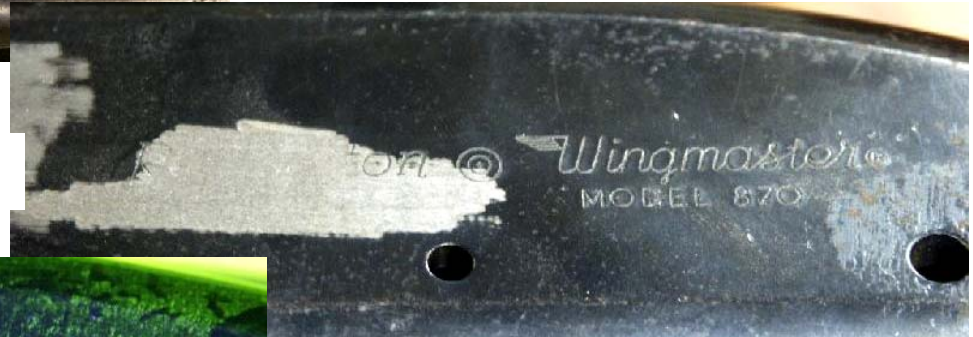
ground away with Dremel

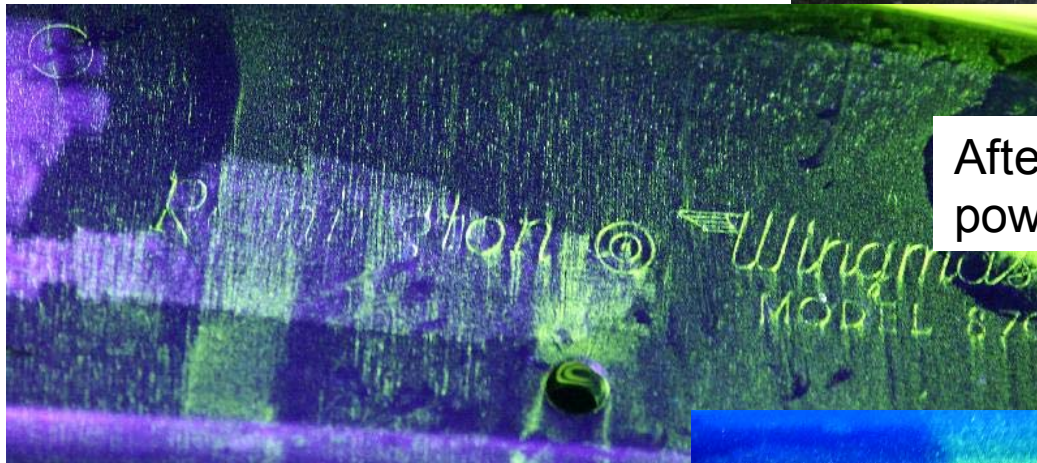
After testing in coil using “DC”
power & bath - #T668337V

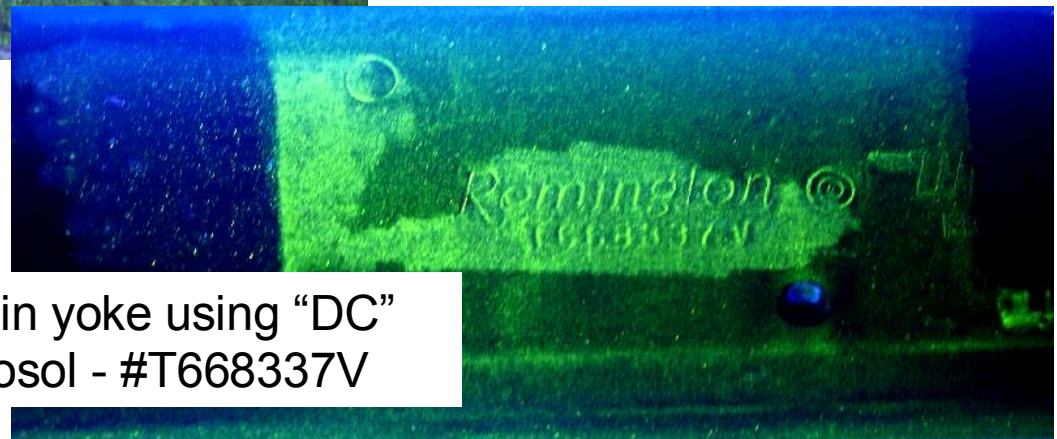
After testing in yoke using “DC”
power & aerosol - #T668337V

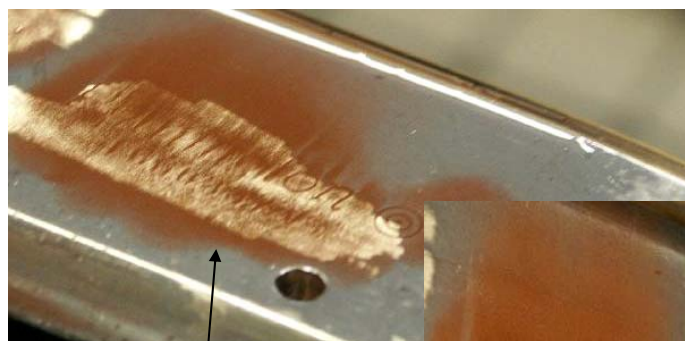
Using AC power
to yoke

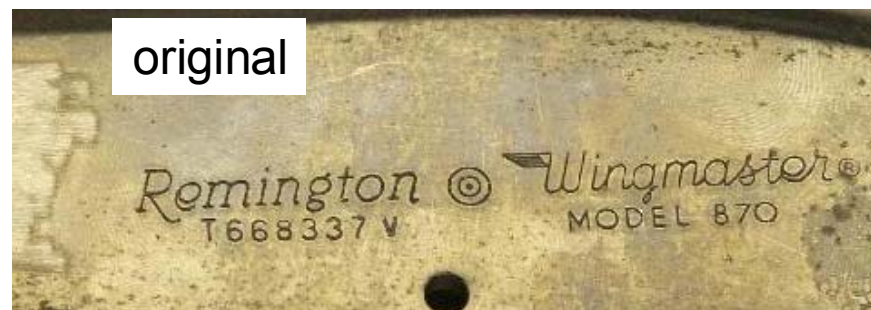
original

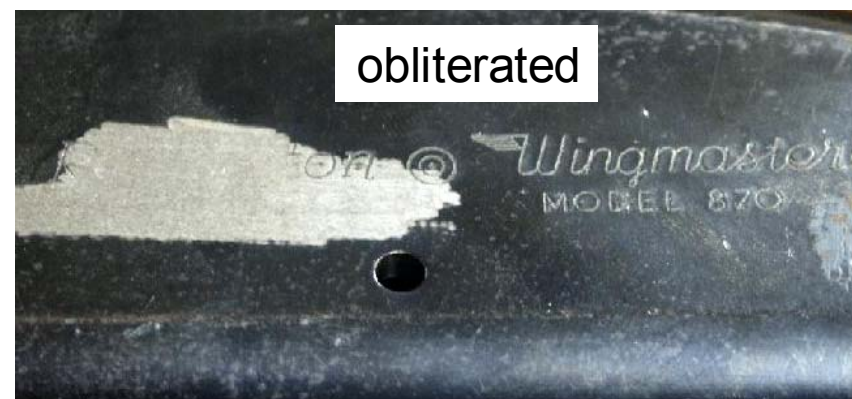
obliterated

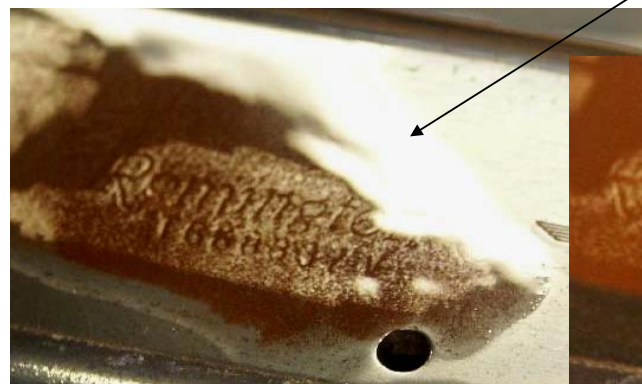
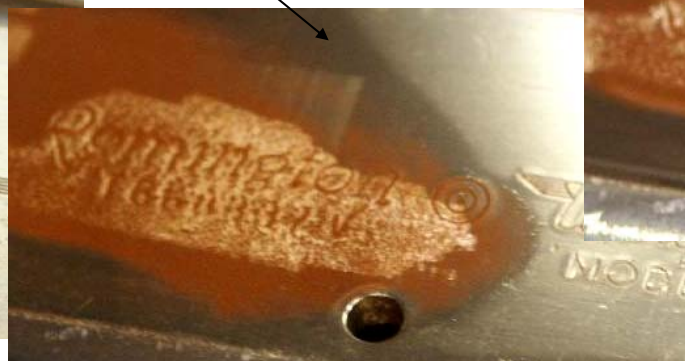
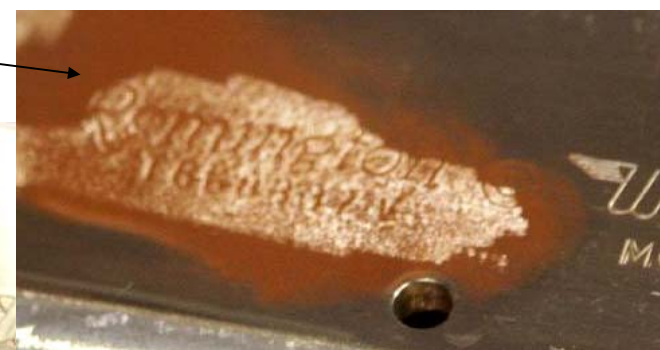
Using DC power
to yoke

- Close-up of ground serial number region on shotgun
- at 7X the “obliterated” words and numbers are very subtly evident

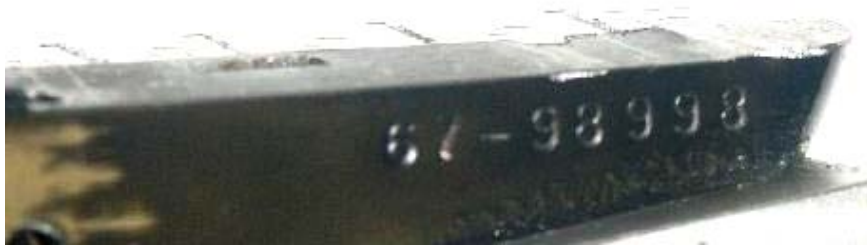
As received – Ruger single-6
.22 cal #67-98998

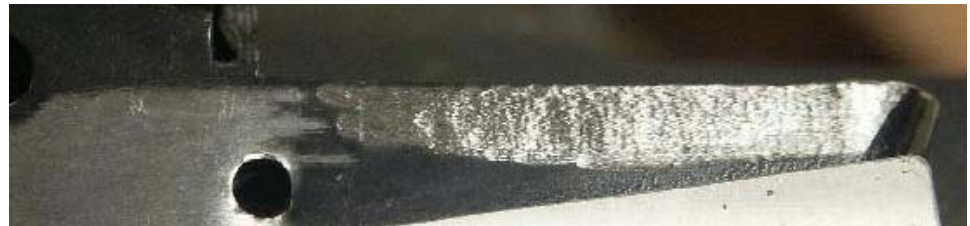
ground away with Dremel

After testing in coil using “DC”
power & bath – no # visible

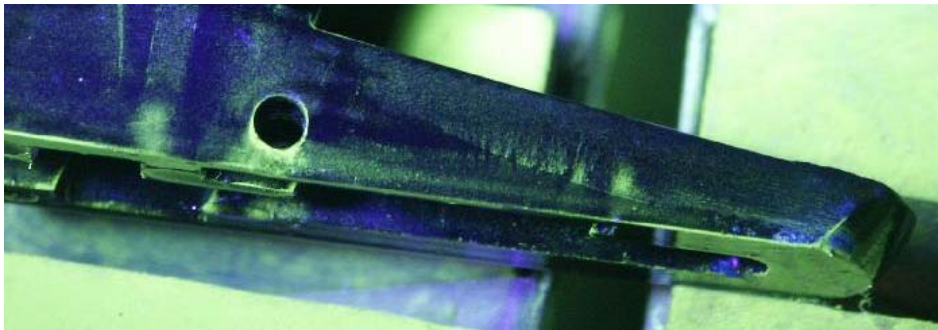
After testing in yoke using “DC” power &
aerosol - # beginning to slightly appear

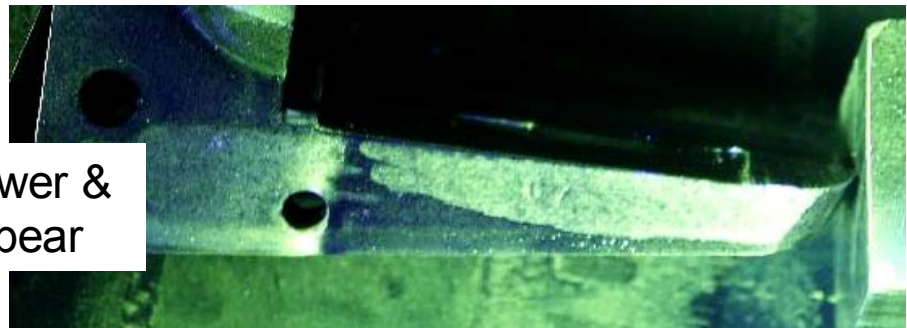
As received – Ruger single-6
.22 cal #67-98998

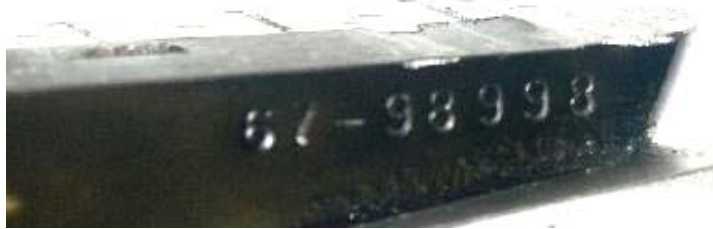
Rough ground

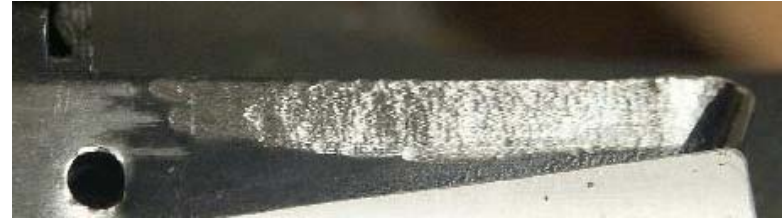
Polished

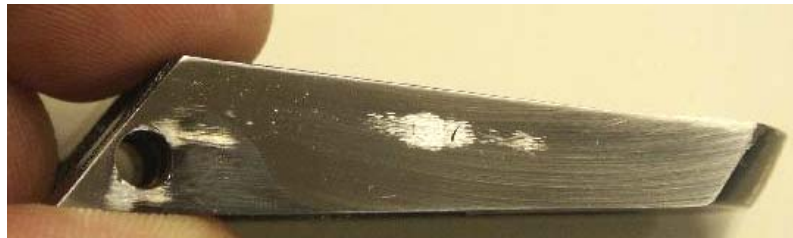
Using DC power to yoke with aerosol fluorescent
particles – serial # more visible

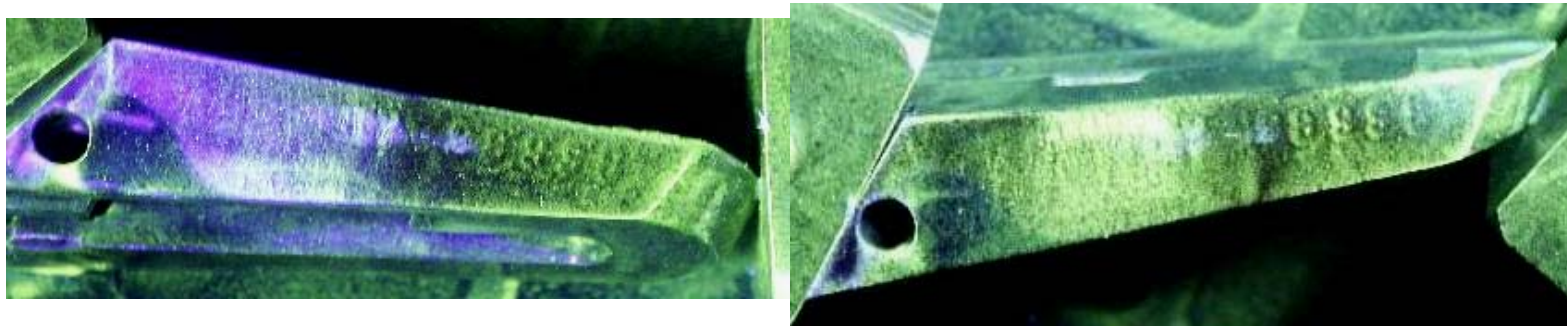
Ruger single-6 .22 cal -
name partially ground

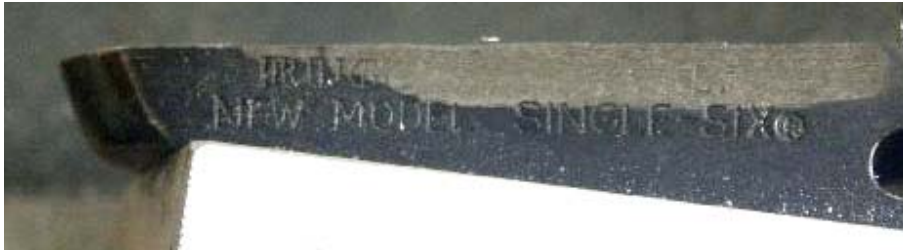
Name polished

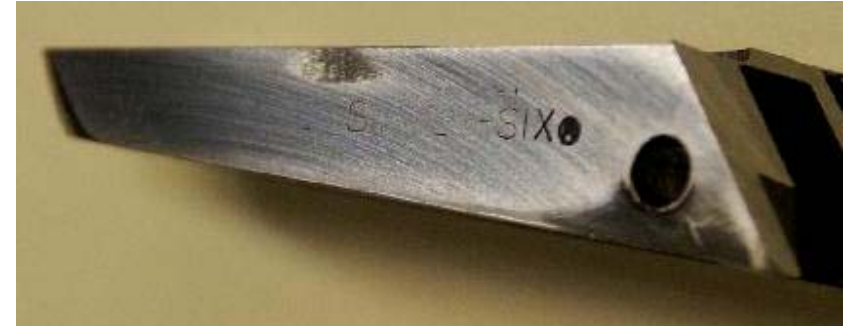
Using DC power to yoke - missing words clearly
visible

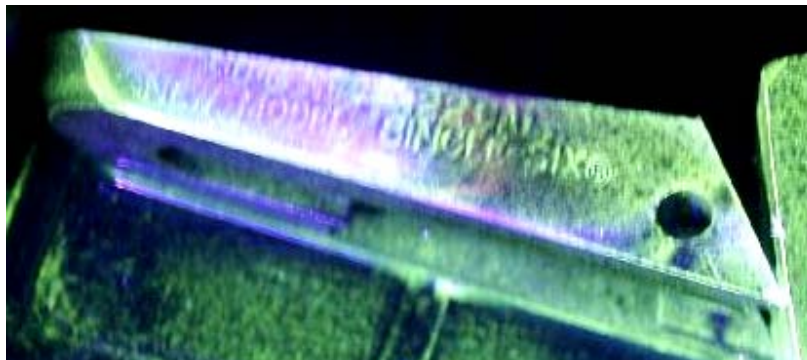
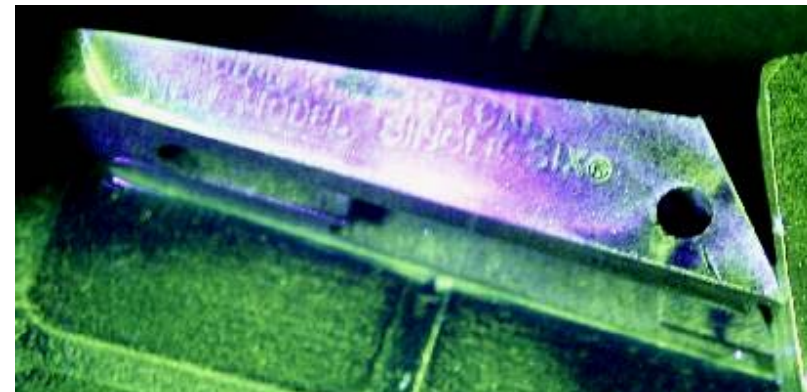
Ruger single-6 .22 cal #67-98998 and name,
after polishing and testing in DC coil – results
poor

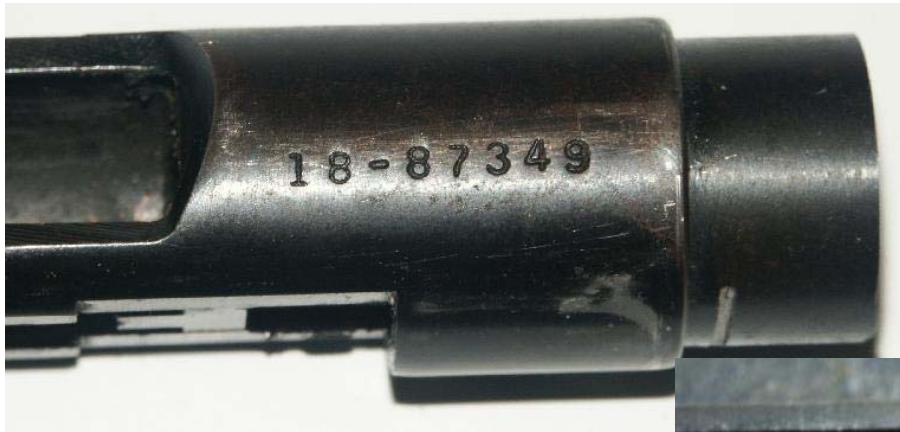
As received – Ruger target .22 cal

ground away with Dremel

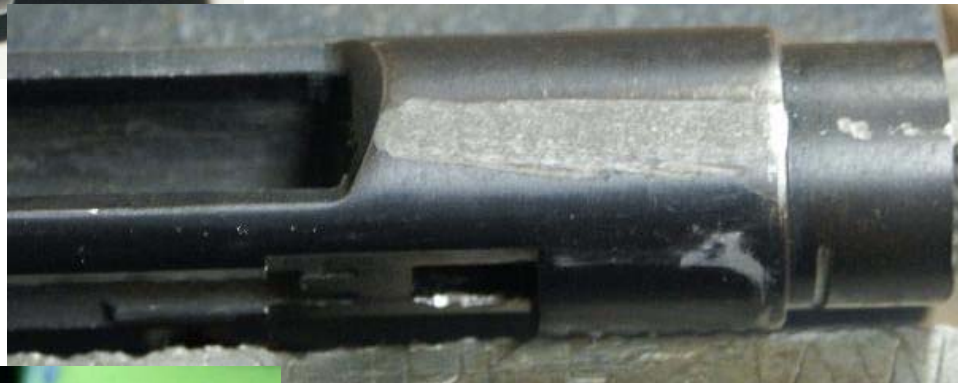
After testing in coil using “DC”
power & bath – # not quite visible

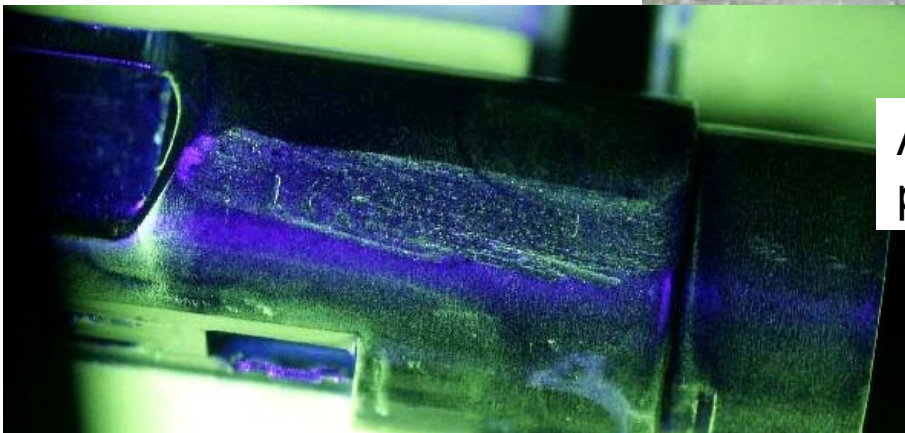
After testing in yoke using “DC”
power & aerosol – no improvement

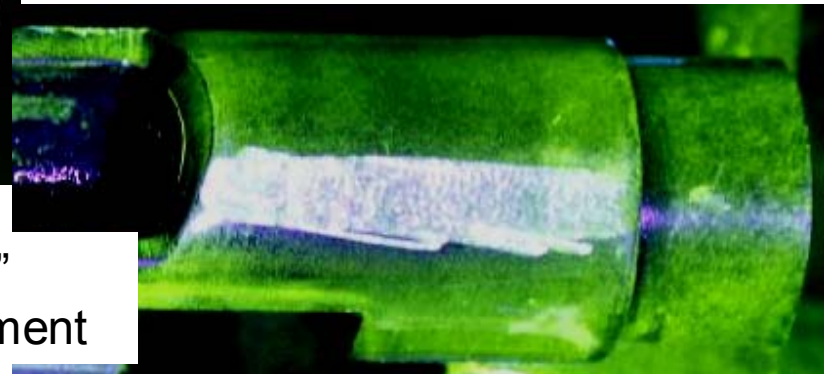
Ruger target .22 cal – after polishing & testing with DC yoke – nothing clearly visible, but shadowy numbers seen

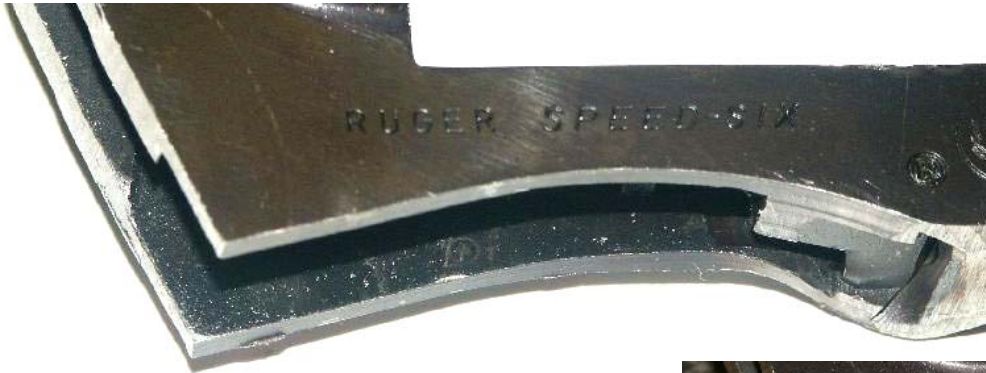
As received – Ruger speed-6
.357 cal

name ground away
with Dremel – (not
much of a challenge
when viewed with
magnification)

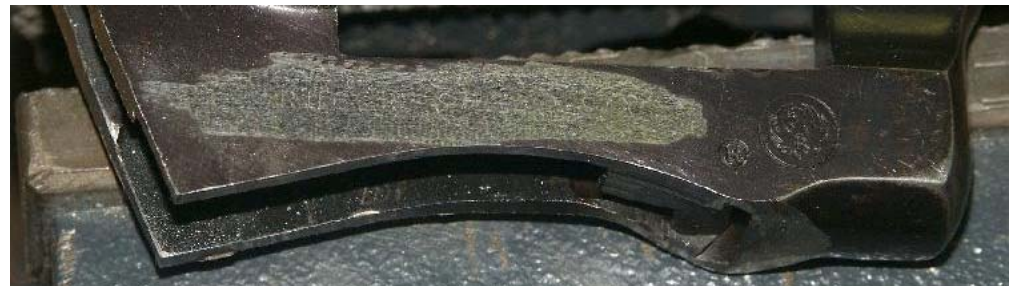
After testing in coil using “DC”
power & bath – name visible

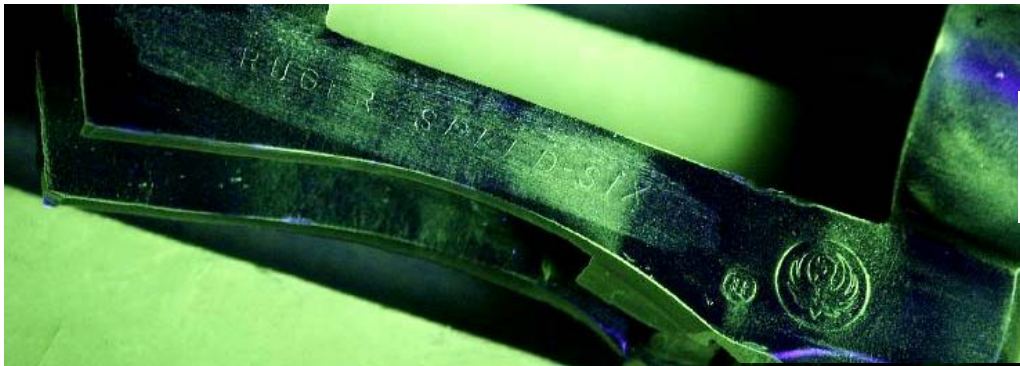
After testing in yoke using “DC”
power & aerosol – no improvement

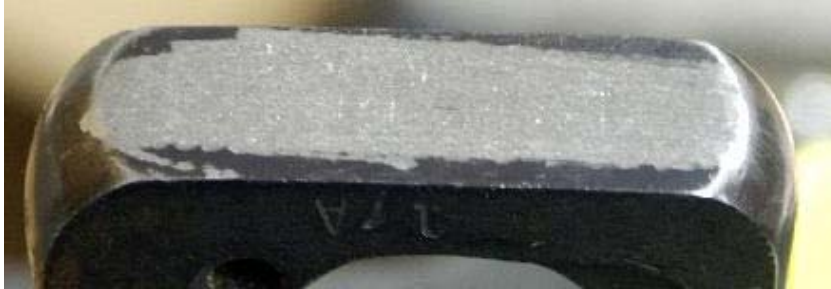
Ruger speed-6 .357 cal –
serial # ground away
(*should read 153-11743*)

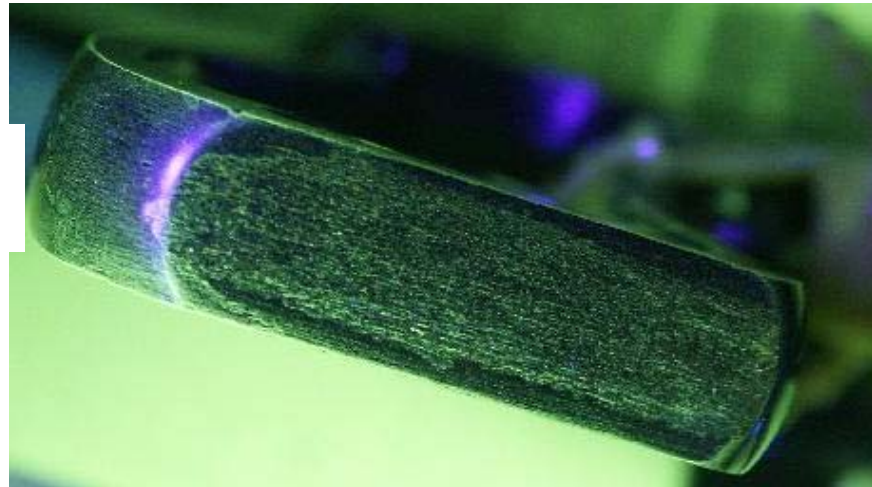
After testing in coil using “DC”
power & bath – # not visible

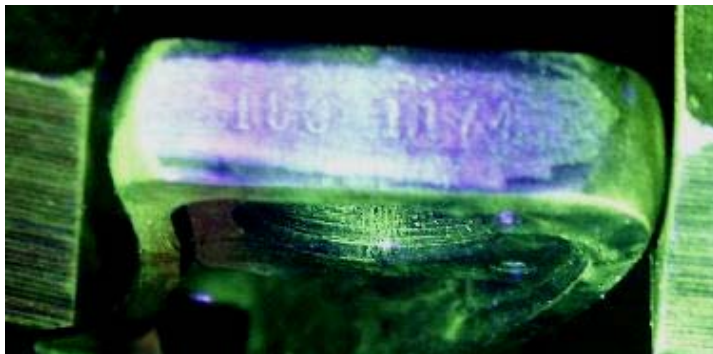
After testing in yoke using “DC” power
& aerosol - # beginning to appear

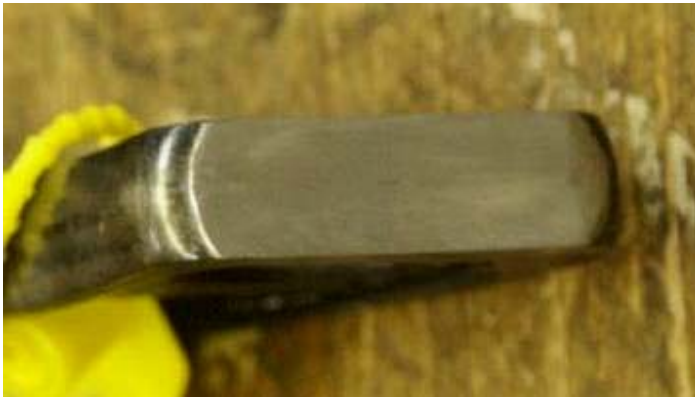
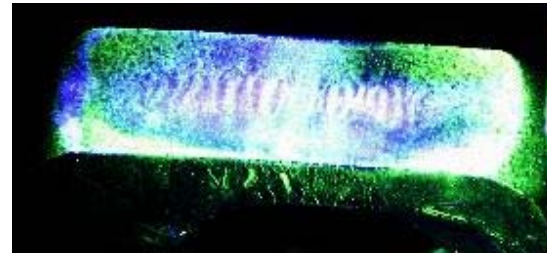
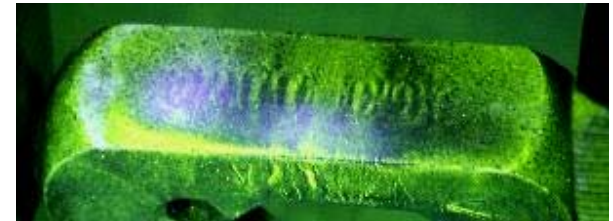
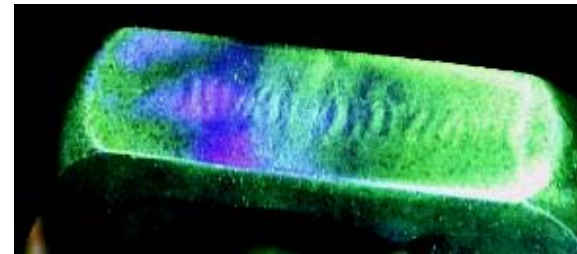
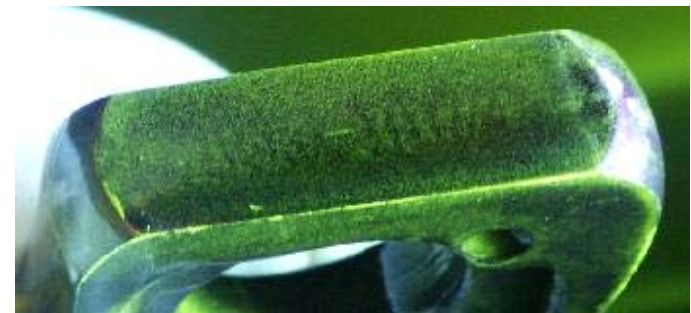
Ruger speed-6 .357 cal – after
polishing and testing in DC yoke,
DC coil – something appearing, not
very clear

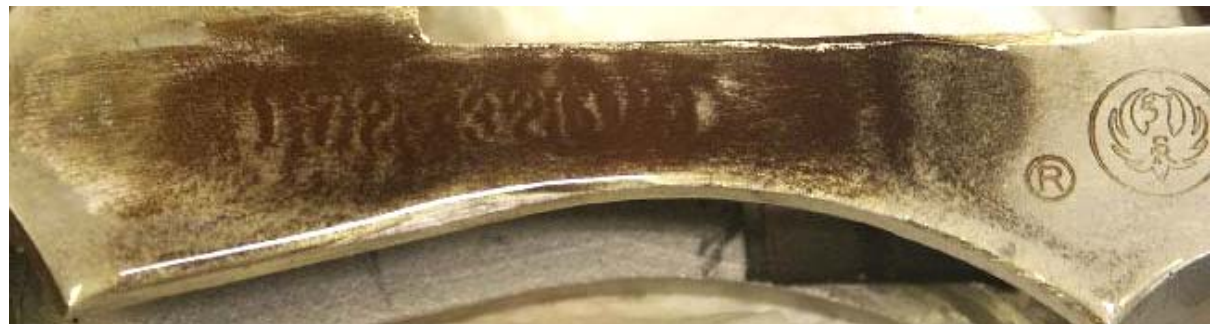
After testing in yoke using "DC"
power & visible particles – some
numbers appearing

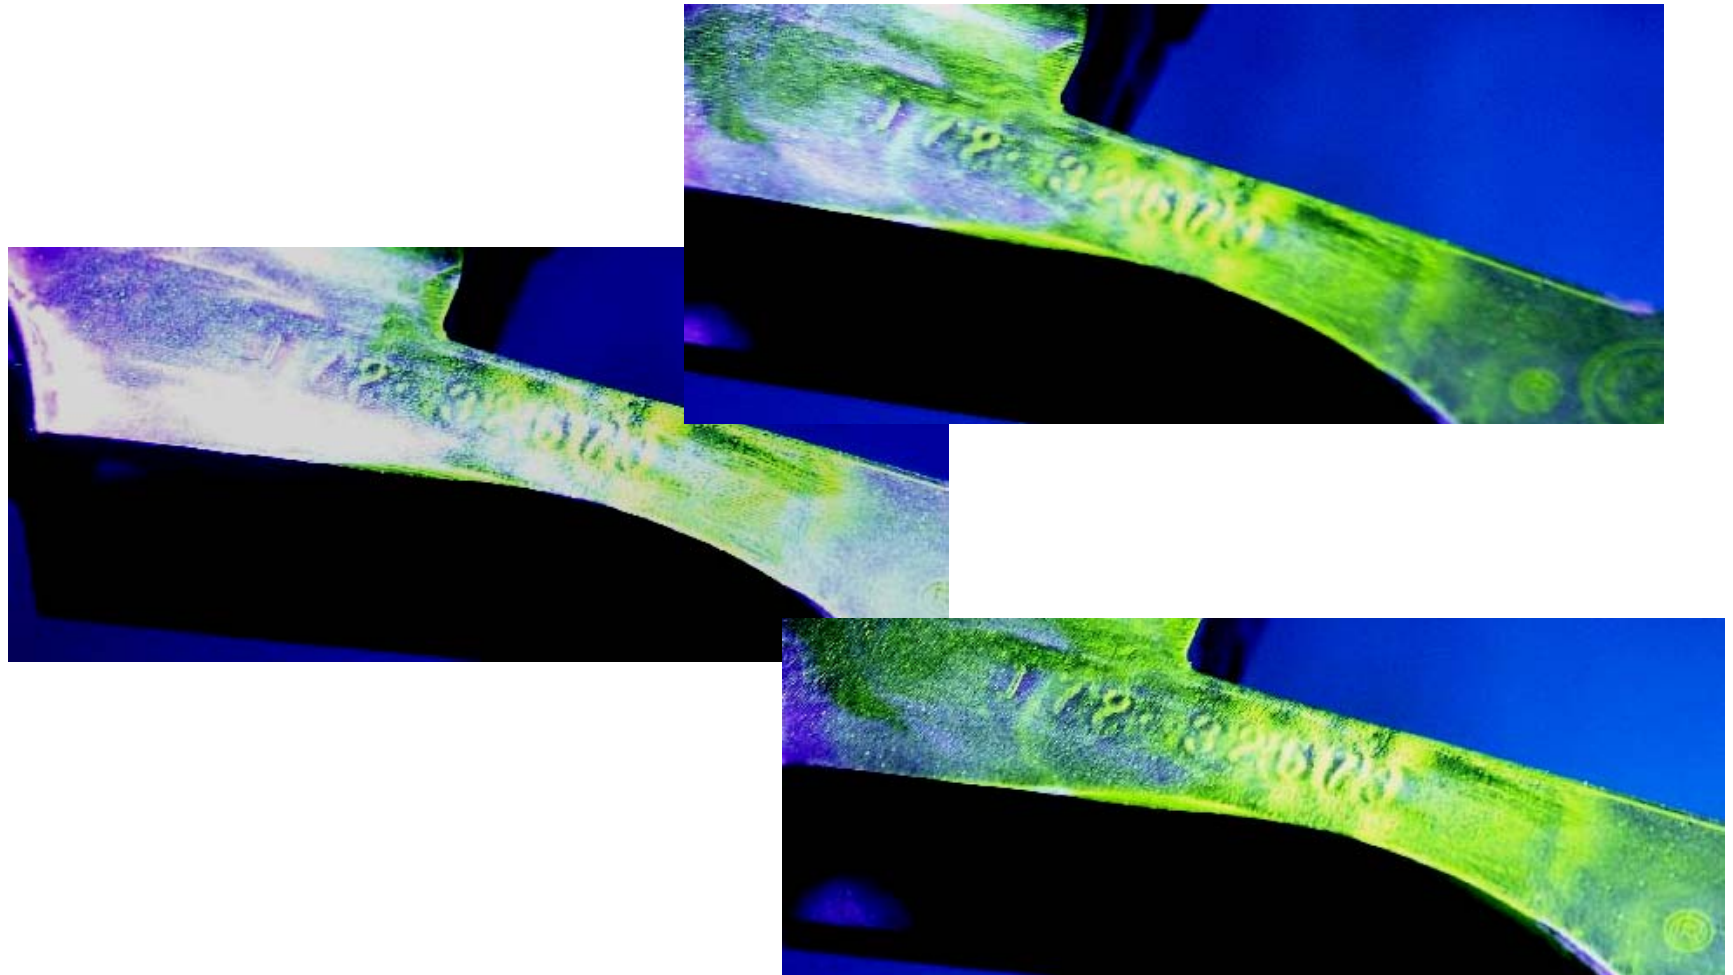
After testing in yoke using “DC” power
& fluorescent particles – numbers fairly
visible – correctly reveal #172-32573

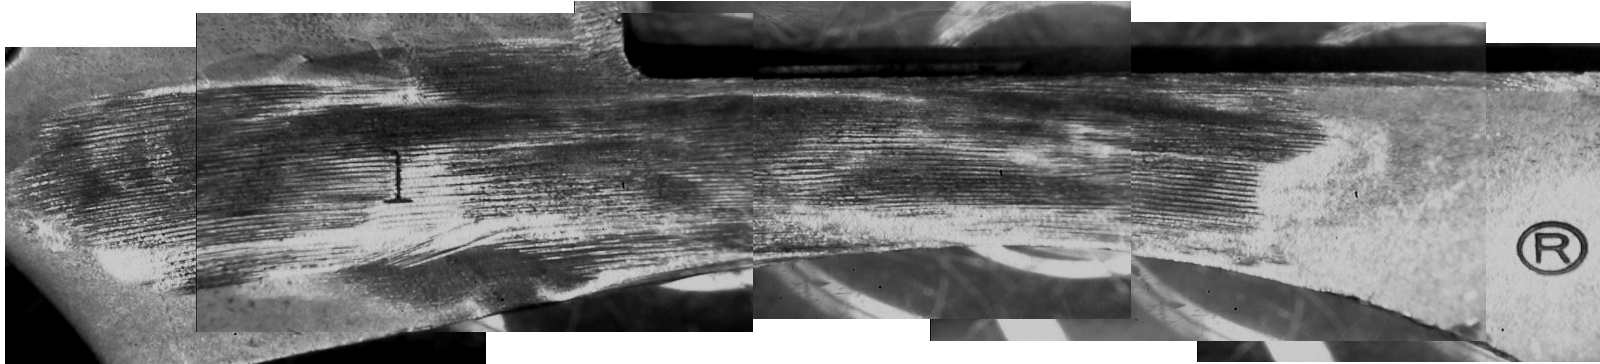
Close-up of obliterated serial number
indicates that it was not an easy challenge
– number should read 172-32573

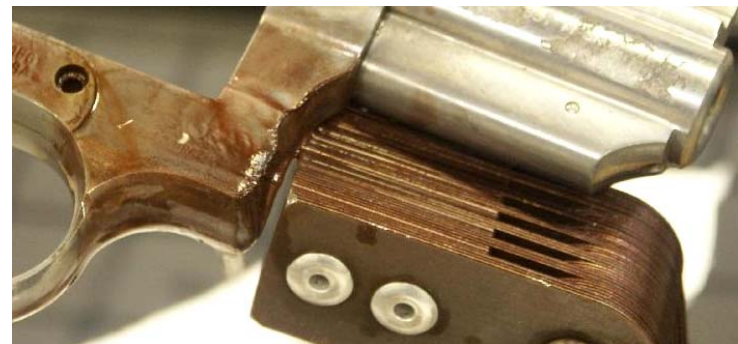
After testing in yoke using “DC”
power & visible particles – number
not visible

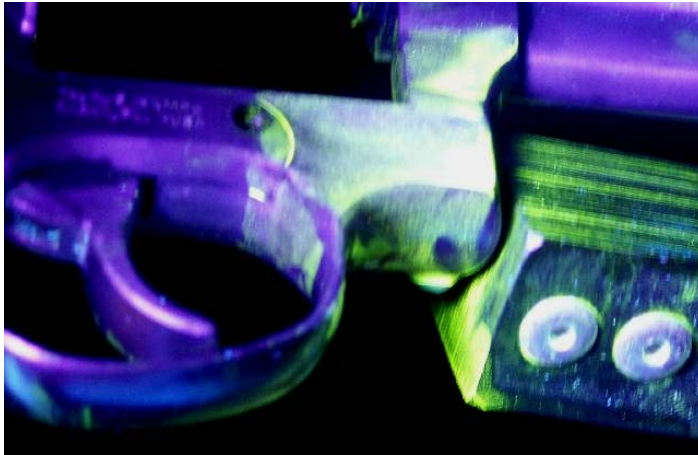
After testing in yoke using “DC”
power & fluorescent particles –
number not visible
